SUBJECT: A Maintenance Worker Dies from Exposure to Dichloromethane (Methylene Chloride) While Stripping the Floor of a Baptismal Font in a Church

SUMMARY
California FACE Report #12CA002

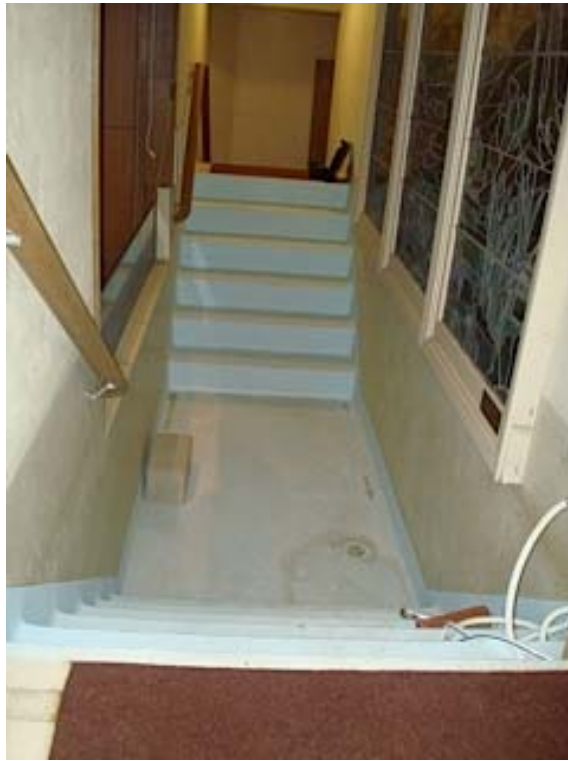
The incident scene was the baptismal font within the main worship area of the church. The baptismal font for this church was a built-in fixture of the church that resembles a large walk-in bathtub. The baptismal font was located within a narrow room (41' long x 4' wide x 12' high) with doors at each end and a large window facing the congregation to allow the worshipers to witness baptisms (see Exhibit 1). The baptismal font was

eight feet long by four feet wide. The font was made out of a common resin that had been painted. The paint coating was peeling and needed to be stripped about every 3 to 5 years.

Exhibit 1. The floor and stairs of the baptismal font.

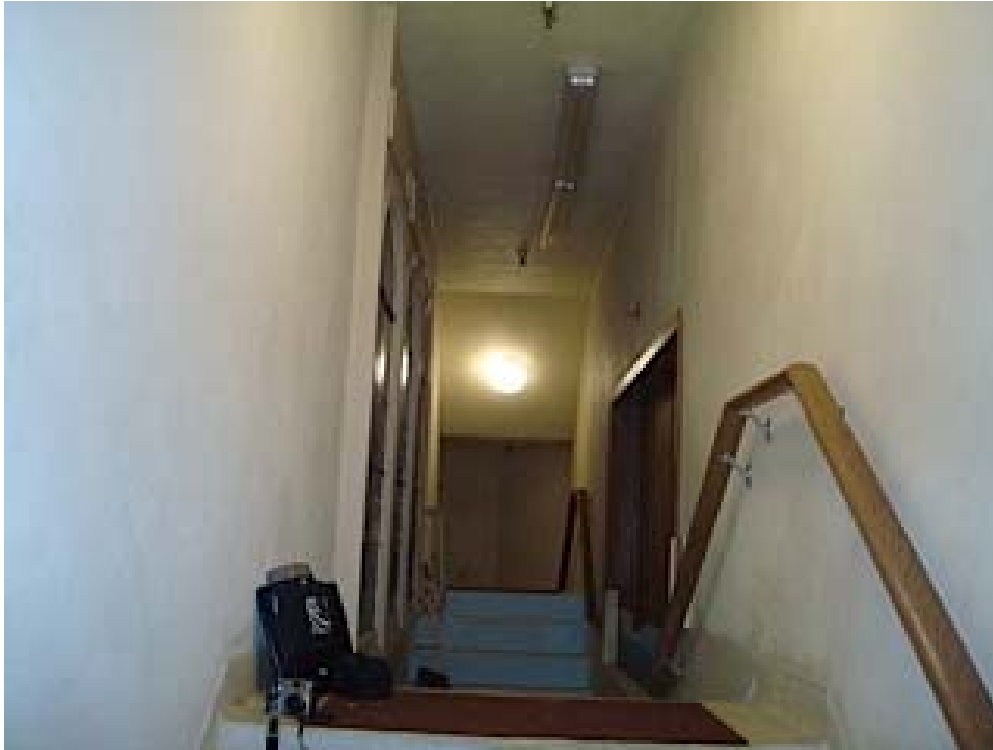
Exhibit 3. The narrow hallway leading to the baptismal font.

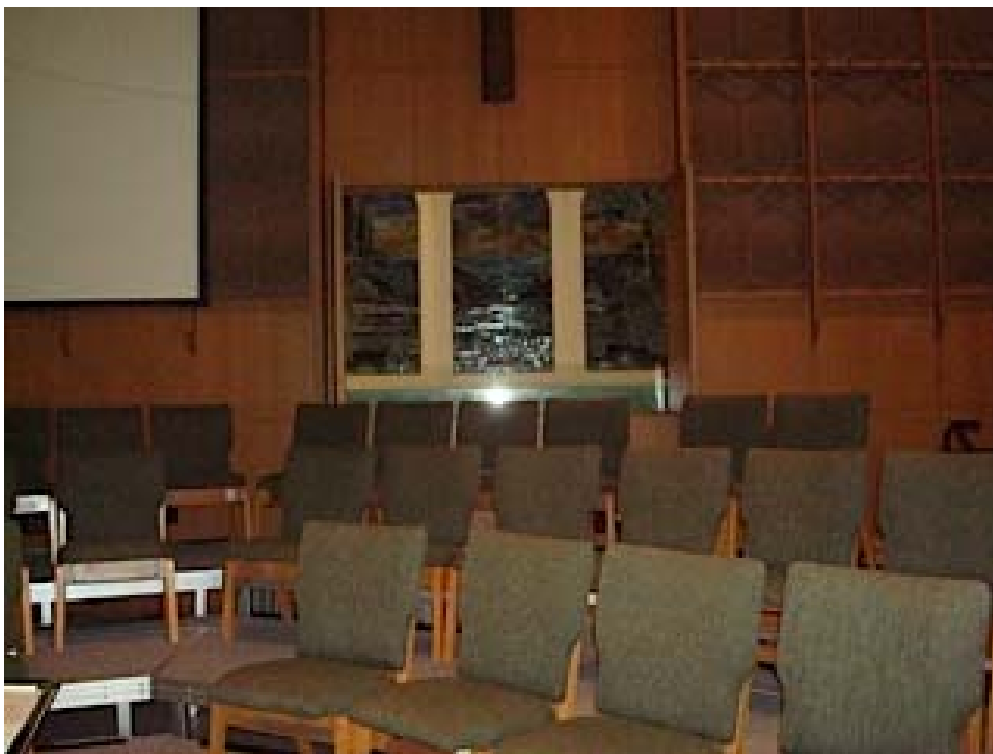
Exhibit 4. A view of the baptismal font from inside the worship area.
